Case Report

Inappropriate ICD Shocks for Inappropriate Reasons

Rakesh K Pai MD, Moeen Abedin MD and David A Rawling MD

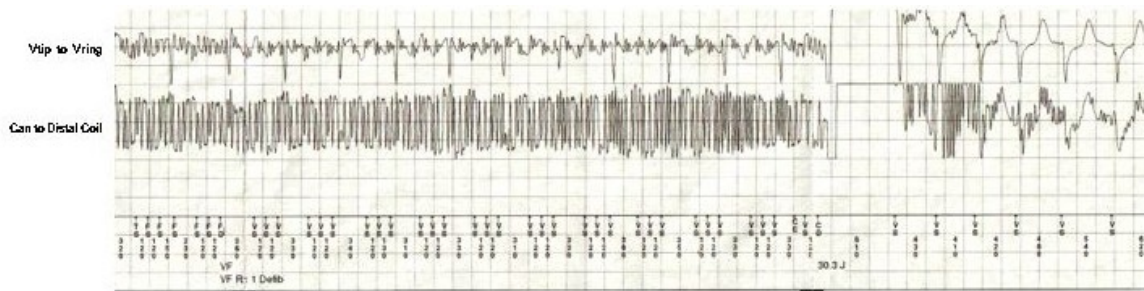
A 38 year old woman with normal left ventricular function, normal cardiac MRI, and a history of sustained monomorphic ventricular tachycardia at 240 beats per minute (left bundle morphology, superior axis) was implanted with a single chamber Medtronic Maximo VR 7232 (Medtronic Inc, Minneapolis, MN USA) implantable cardioverter-defibrillator (ICD) in 2001. The patient had never received an ICD shock over six years of follow-up. In the summer of 2007, the patient received a single ICD shock. The ICD interrogation (**Figure 1**) revealed a high frequency 50 Hz artifact on the ventricular channel sensed by the device as ventricular fibrillation, a 30 Joule shock was delivered. There was no evidence of ICD malfunction, with a ventricular sensitivity of 0.3 mV, R waves of 6.1 mV, with ventricular lead and shock impedances of 400 Ohms and 55 Ohms, respectively. Upon further questioning, it was discovered that the patient was swimming within two feet of an underwater pool light. The light had "shocked" several swimmers in the past. An electrician confirmed light malfunction due to improper grounding with evidence of current leak into the pool. We report an unusual case of an inappropriate ICD shock caused by the ICD sensing alternating current from an unexpected external source.

Figure 1: The near field ICD electrogram (V tip to V ring) is present on the top, and the ICD shock electrogram (Can to Distal coil) is on the bottom. Note the high frequency noise present on both sets of electrograms. The patient receives a single 30 Joule shock; however, the noise persists and only begins to dissipate after she receives the shock (last few seconds of the tracing) and begins to swim away from source of alternating current leak.

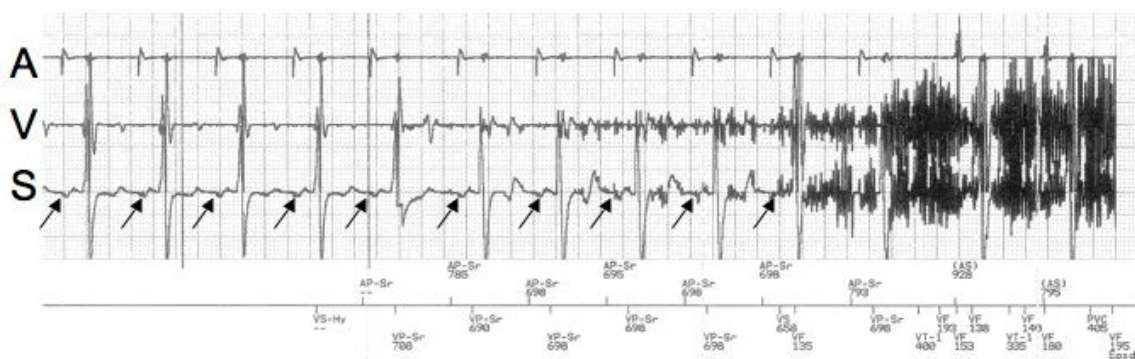
A 70 year old man with a history of ischemic cardiomyopathy, nonsustained ventricular tachycardia and sinus node dysfunction was upgraded from a dual chamber pacemaker to a dual chamber Guidant Vitality 2 DR ICD model T165 (Guidant Inc, St Paul, MN USA) in February of 2007. During ICD testing a single 20-Joule reverse polarity shock terminated VF. In June 2007, the patient presented for routine follow-up and during this visit he reported receiving a single ICD shock in March. He felt well and did not seek medical evaluation at that time. The ICD interrogation revealed a high frequency artifact on the ventricular channel sensed by the device as VF, and a single 20-Joule shock was delivered. In addition there were numerous stored EGMs demonstrating high frequency noise (**Figure 2**) recognized as VF but none were sustained long enough to trigger ICD therapy. There was no evidence of malfunction; R waves were 24 mV, capture threshold of 0.6 V at 0.5 ms, and the ventricular lead and shock impedances were 706 Ohms and 50 Ohms, respectively. The noise could not be reproduced by isometric maneuvers or with pocket manipulation.

Figure 2: The atrial sense channel electrogram (A) is present on the top, the near field ventricular sense channel (V) is present in the middle tracing, and the ICD shock (S) electrogram is on the bottom. Very high frequency pectoral myopotentials are present and sensed by the device as VF (marker channel) on both the V and S electrograms. In this particular tracing the episode was nonsustained and did not trigger ICD shock therapy. The presence of p waves and pectoral myopotentials on the shock electrogram is suggestive of reversal of DF-1 lead terminals, allowing for unipolar sensing from distal coil to the ICD can.

distal ICD DF-1 pins were reversed in the header, resulting in a sensing circuit from the distal coil to the can. This broad unipolar sensing configuration allowed the detection of pectoral myopotentials, precipitating an inappropriate ICD shock.^{3,4} A diagnostic clue for this etiology of inappropriate shock is the presence of p waves (**Figure 2; arrows**) on the ICD shock EGMs. The high frequency noise artifact is unlikely to be due to EMI, as there is no noise seen on the atrial lead. Furthermore, lead fracture is less likely given adequate sensing and capture thresholds with normal lead impedances. Surprisingly, the patient was successfully defibrillated at initial implant; however, the shock energy pathway from the proximal SVC coil to the distal coil and ICD generator can shunt energy away from the ventricles and is unproven in cardioverting ventricular arrhythmias. The patient was taken to the electrophysiology laboratory and proximal and distal DF-1 pin reversal was confirmed. The DF-1 distal and proximal lead terminal positions were corrected and VF was terminated with a single reverse polarity 14-Joule shock. The patient went home the same day and had no further complications. We present two unique cases of inappropriate ICD shocks due to EMI from an unexpected source alternating current and reversal of the proximal and distal DF-1 lead terminals of the ICD lead.
