Interesting ECG

Right bundle branch block pattern during right ventricular permanent pacing: Is it safe or not?

Okan Erdogan, MD, Feyza Aksu, MD

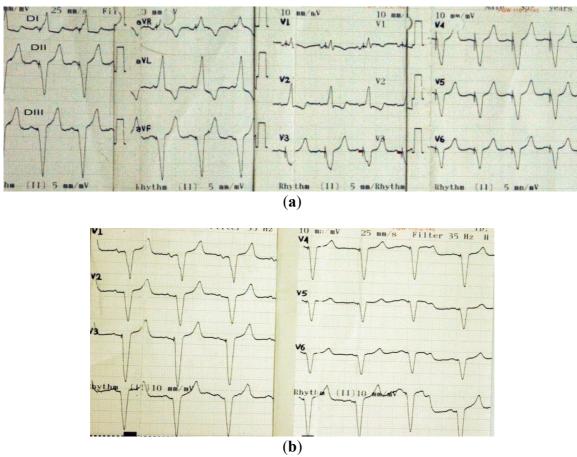
Figure 1. (a) Surface ECG showing atrial tracking and ventricular pacing with right BBB pattern in V1 and V2 (Rs and R complexes) associated with a frontal axis of -60°. (b) Moving the leads V1-2 one interspace lower than standard results in left BBB configuration with the inscription of QS complexes in leads V1 and V2.

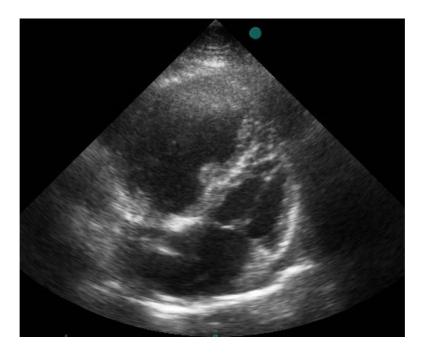
Figure 2. Parasternal transthoracic echocardiographic view demonstrating and confirming the ventricular pacing lead going from the right atrium to the right ventricle with its tip located in the apical position.

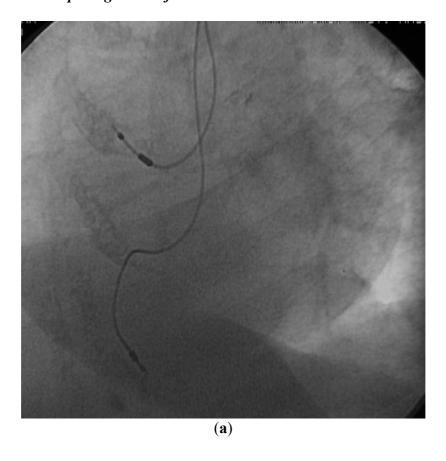
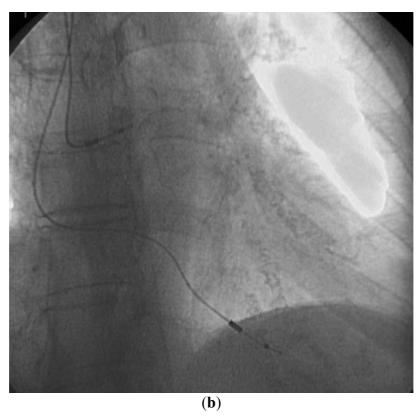
Figure 3. (a) Fluoroscopic view (45° left anterior oblique) nicely shows both atrial and ventricular leads on the right side of the septum. The tip of the ventricular lead is fixed in the distal infero-apical position of the right ventricular apex. (b) Fluoroscopic view (30° right anterior oblique) shows the ventricular pacing lead oriented anteriorly and inferiorly in the right ventricular apex.
