Case Report

Inappropriate Shock Delivered By Implantable Cardioverter Defibrillator - Cardiac Resynchronization Therapy (ICD-CRT) Due To Myopotential Oversensing

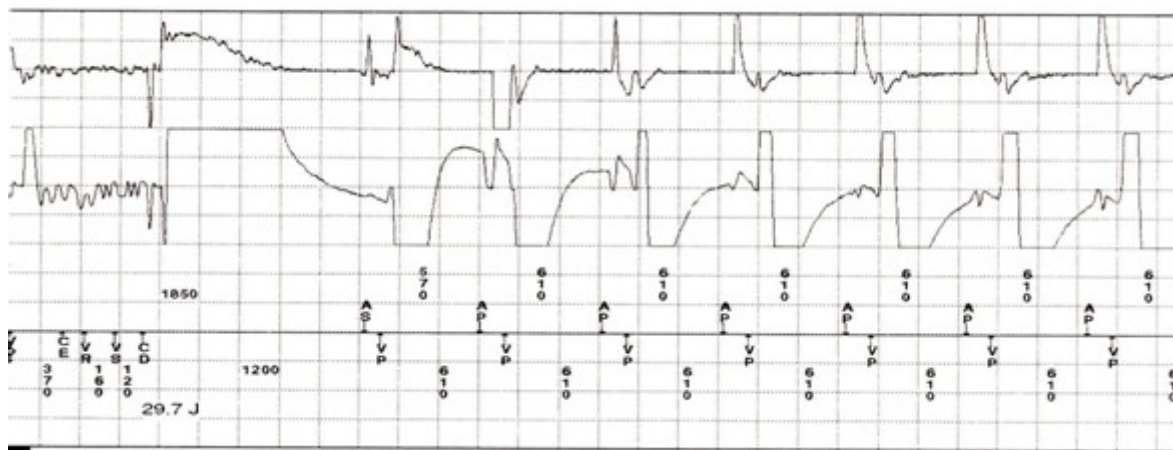
Figure 1

Twenty days later, the patient presented for regular follow up at the ICD clinic. Upon interrogation of the device, the counters revealed one episode of VF, for which a 29.7 J shock was delivered at the time of mentioned event (**Figure 1**). EGM revealed regular appearance of R-waves at an interval of about 610 ms; however there was undulating high frequency noise distorting the baseline corresponding to the time of forceful muscular contractions (**Figure 2**). This noise disappeared after delivery of the shock. The device interpreted (detect) this episode as VF, resulting in capacitor charging for VF therapy (charge). To determine the mechanism of electrical signal oversensing, we replicated brief noise by asking the patient to make a sudden strong forward movement against resistance. Impedance of the high voltage lead was within the normal range (50 Ohm) and the episode lasted for 9 seconds. Further interrogation of the defibrillator did not reveal any detrimental alteration in the pacing/ICD leads or the ICD circuit. To avoid inappropriate shock, we programmed longer duration of detection in the VF zone. No recurrence was observed during follow-up with the newly programmed parameters.
