## Case Report

# A Rare, Late Complication after Automated Implantable Cardioverter-Defibrillator Placement

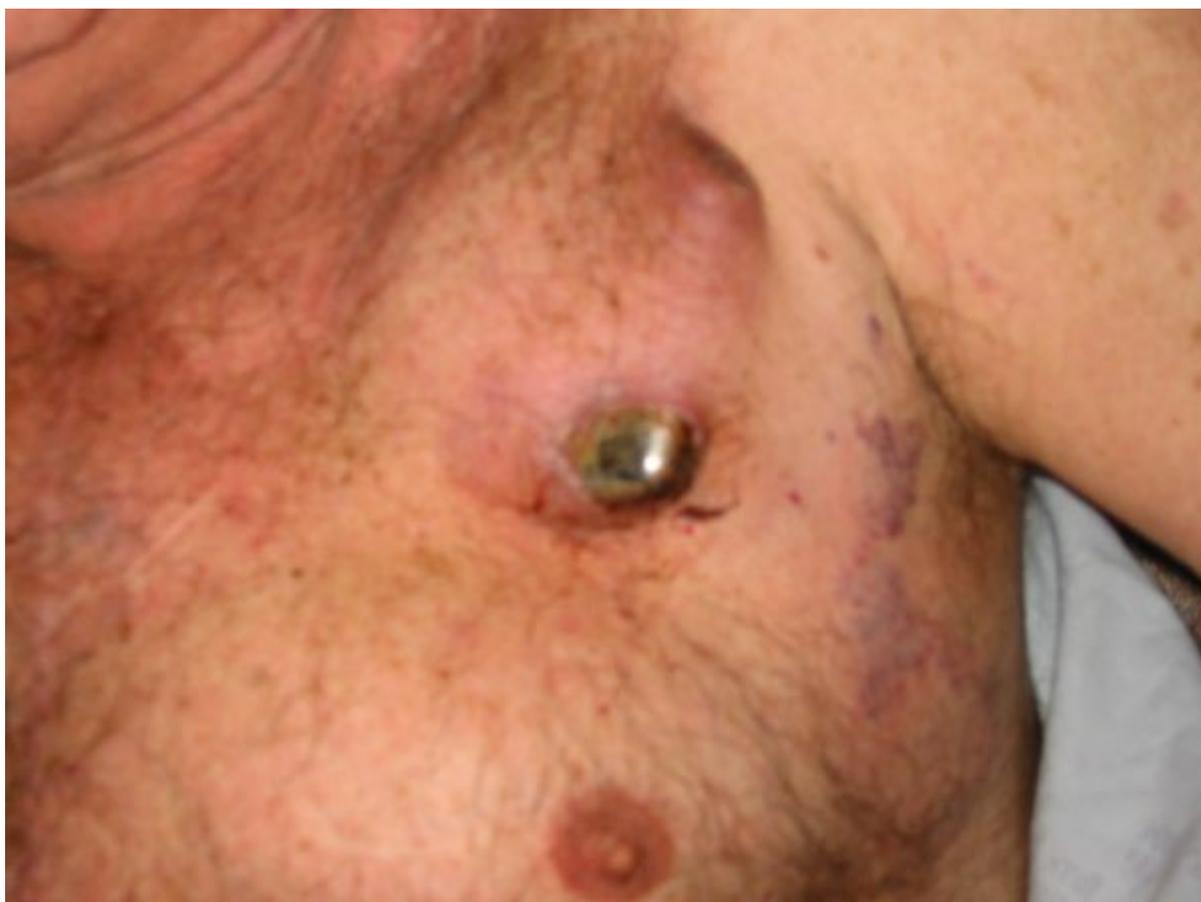
**Figure 1.** Erosion of the AICD through the skin. Note upper right corner of subcutaneous pocket shows severe erythema with signs of pre-erosion.

The other cause of skin erosion is pressure necrosis of the overlying tissue and skin.<sup>3</sup> Gross pacemaker extrusion is usually signaled by a preceding period of “pre-erosion,” during which there is discomfort and discoloration of thinning tissue tensely stretched over a protrusion of the pacing apparatus (**Fig. 2**). Griffith et al. concluded that if pacemaker erosion is not caused by infection it can be successfully managed by ipsilateral re-implantation, a financially

advantageous solution.<sup>5</sup> Identification of pre-erosion allows salvage of the pacing system, as the hardware can be repositioned under the pectoralis muscle or in an abdominal location.

If true erosion occurs, the system is considered contaminated and current opinion favors removal of the generator and leads. Extensive debridement of the pocket and prolonged irrigation and antibiotic therapy may provide an alternate option to removal in cases of both erosion and frank infection,<sup>7</sup> but this approach is not generally preferred. Attempts have been made to preserve the implanted leads by debriding locally and severing the pacemaker leads while leaving them in situ. However, given the relative safety and efficacy of percutaneous lead removal, complete removal of the leads is the ideal approach if sterility is questioned.

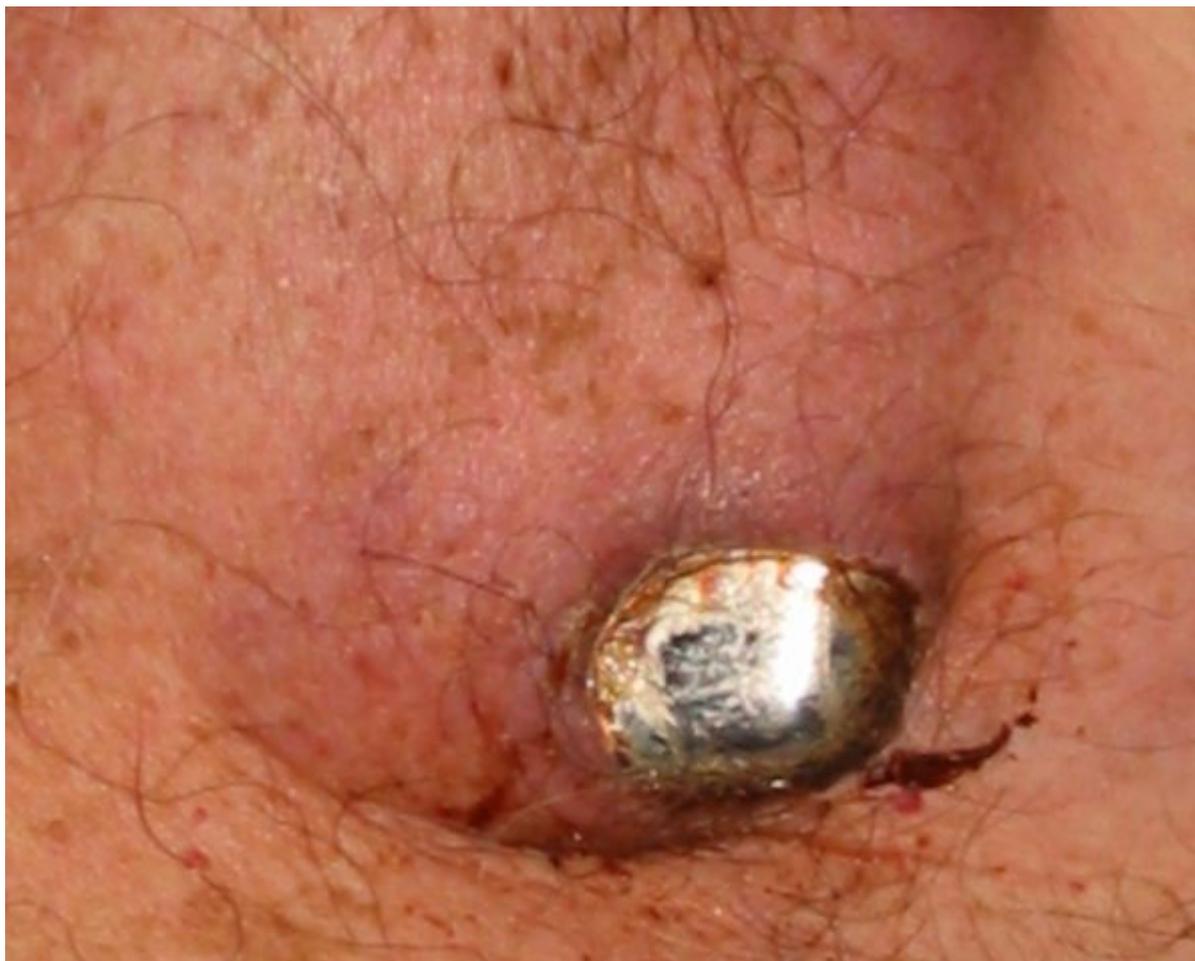
**Figure 2.** Close up examination of AICD eroding through the skin.
